Mitroflow Bioprosthesis Stent Deformation: A Rare Cause of Early Prosthetic Stenosis

Javier Gualis, Mario Castaño, Jesús Gómez-Plana, Francisco Callejo

Department of Cardiovascular Surgery, León City Hospital, León, Spain

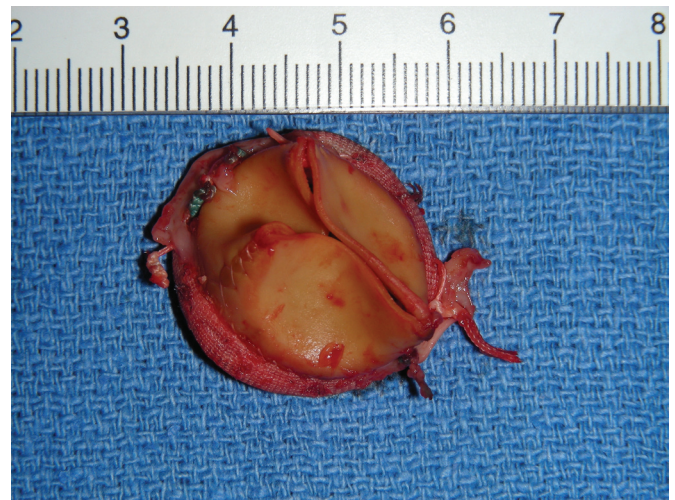
Figure 1. Asymmetric orientation of posts, central kinking, and abnormal stiffening of the right coronary sinus leaflet, along with aortic outflow tract obstruction.

Abundant clinical experience supports the widespread use of the Mitroflow stented aortic bioprosthesis as a valve substitute with good long-term follow-up in terms of structural degeneration [García-Bengochea 2006; Sjögren 2006] and valve-related events [Pomar 1998; Thulin 2000]. Excellent hemodynamic performance, especially in small aortic roots [Totaro 2000; Gerosa 2006], that is comparable in some reports with that of stentless tissue valves, tends to lead to early and significant regression of left ventricular mass, a major determinant of late mortality [García-Bengochea 2006; Sjögren 2006]. Moreover, the stent of this prosthesis is extremely flexible. This feature makes its implantation simpler in patients with significantly calcified or small aortic roots [Totaro 2000; Gerosa 2006]; however, such flexibility can potentially favor permanent stent deformation in cases of abnormal tensional forces via suture maldistribution or significantly deep aortic sinuses in a severely rigid and calcified annulus. In our case, the reoperation revealed that the portion of Dacron rim corresponding to the right coronary leaflet included fewer mattress sutures than the left coronary and noncoronary sinus rim segments. This suture distribution induced plication of the stent in the right coronary portion and proportional stretching in the other 2 segments. Consequently, the right

coronary leaflet of the prosthesis kinked down to the aortic outflow tract and induced aortic valvar stenosis.

In conclusion, we think that despite significant asymmetry in the length of the native aortic cusps, sutures must be distributed cautiously and equidistantly along the Mitroflow prosthetic Dacron rim to prevent stent deformation. We strongly believe that this recommendation can improve the mid- and long-term freedom from structural degeneration and reoperation of this prosthesis.

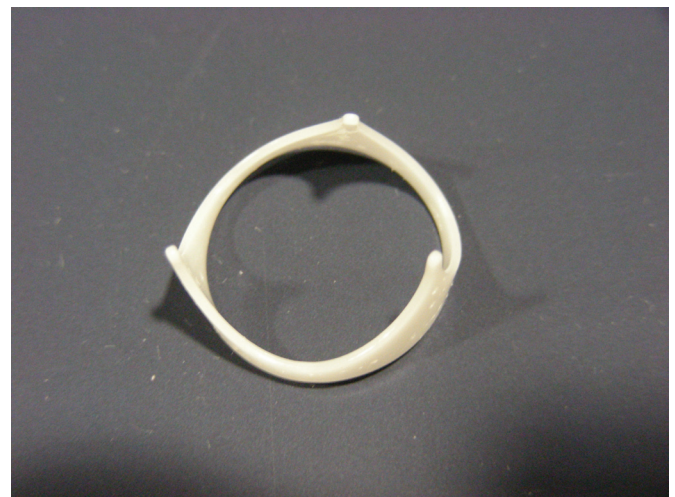
Figure 2. Tridimensional permanent stent deformation as the cause of the asymmetry of both posts and the leaflet kinking.
